# DLC Coating on Axially Floating Bearings for More Electric Aircrafts

Ball bearing selection is critical to a system performance, especially in aerospace industry. Most of the studies focused on improving the bearing performances by reducing the friction between the rolling elements, but little on its behavior within its final assembly. This paper investigates fretting and galling between a bearing liner and a bearing. This study describes a surface engineering method through different axis to improve the design by functionalizing the surface in order to reduce the damage to an acceptable level.

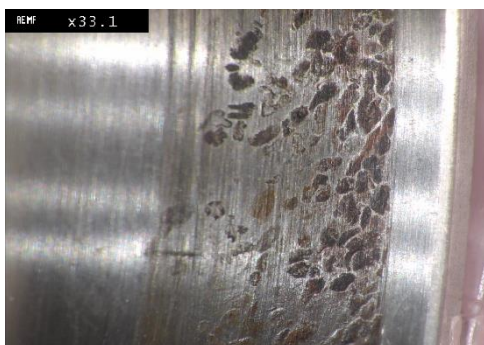
Figure 1: Galling on a bearing liner in MRO

Within the aerospace industry, not all the systems and applications are oil lubricated. Depending on the design, the customer specification and the weight targets, an air cooled design is the best option. However, this can lead to an increase of tribological issues. In this paper, an air-cooled electrical generator running at 17000 rpm is studied. The purpose of the research is to increase the time between overhauls by 150%. Some units after completion of a development test were presenting fretting corrosion and galling as shown in Figure 1. The challenge was to define a suitable solution, fit for flight, to reduce the galling observed and increasing the number of flight hours of the generator.

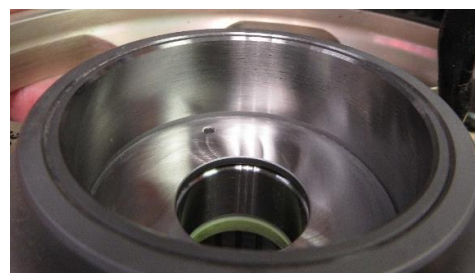
Figure 2: New Bearing liner after test

Several solutions were investigated and some of these has been tested directly on a unit to be representative of the in service conditions. A combination of several solutions were implemented and demonstrated efficient to increase the life of the product in accordance with the defined requirements. Figure 2 shows the bearing liner surface after the completion of 3000 hours of endurance test on a drive stand. The unit is performing as expected and without any sign of galling or other unacceptable damage.
