# In-situ Monitoring of Biomaterials in Fretting-Corrosion Couples

Common biomaterials used in total joint replacement were investigated under a fretting-corrosion contact such as is found in modular tapers. The tribocouples were monitored using live in-situ sensing to assess degradation during sliding. Changing the fretting regime from ‘stick’ to ‘gross-slip’ resulted in increased acoustic emission hit detection and nanocrystallisation at the surface of the material. Under ‘stick-slip’ however subsurface cracking was observed in the sample; coupled with even higher hit counts. Quantification of AE signals could lead to further understanding in how energy is dissipated in such contacts and the formation of surface tribolayers.

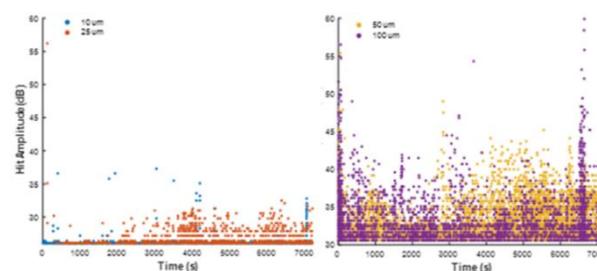
Figure 1: AE Hit Amplitude data for fretting couples at various amplitudes.

The corrosive degradation was found to scale with the fretting amplitude as the regime changed. Moving into ‘gross-slip’ increased DE was coupled with increased AE hit detection and subsurface nanocrystallisation. Under ‘stick-slip’ however lower levels of subsurface change were noted despite even higher levels of AE hit detection. This was explained by observed subsurface cracking; suggesting AE can help quantify different pathways of energy dissipation in-situ.

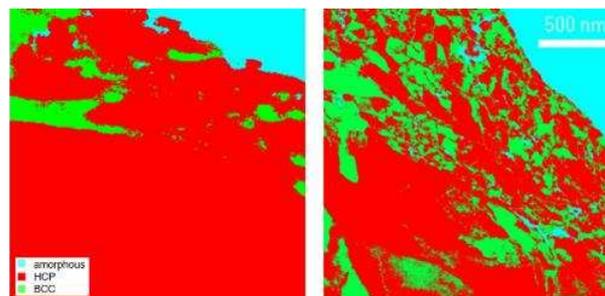
Figure 2: TEM from within the wear scar at 25  $\mu\text{m}$  (left) and 100  $\mu\text{m}$  (right).

After testing, a 10  $\mu\text{m}$  surface cross-sectional slide was taken from within the wear scar in a focused ion beam (FIB) SEM. These slides were then investigated using NanoMEGAS TEM orientation imaging in order to map and quantify subsurface changes to the alloy articulating surface.
